NORWALK RIVER BASIN
WILTON, CONNECTICUT

SOUTH NORWALK RESERVOIR DAM CT. 00212

PHASE I INSPECTION REPORT NATIONAL DAM INSPECTION PROGRAM

DECEMBER 1978

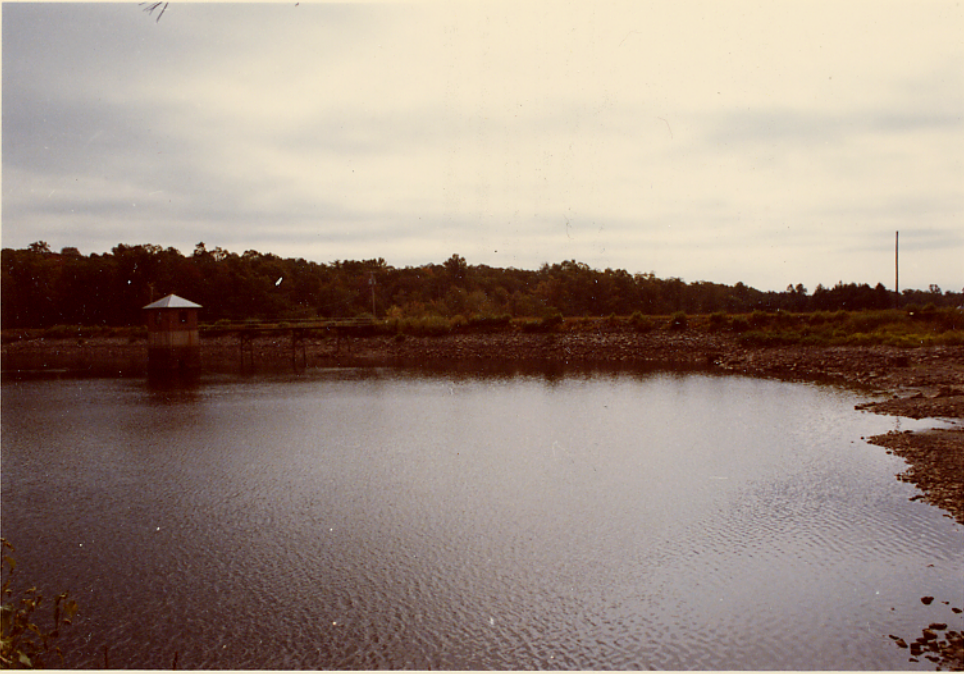
PHOTO 1
GATE HOUSE FROM UPSTREAM

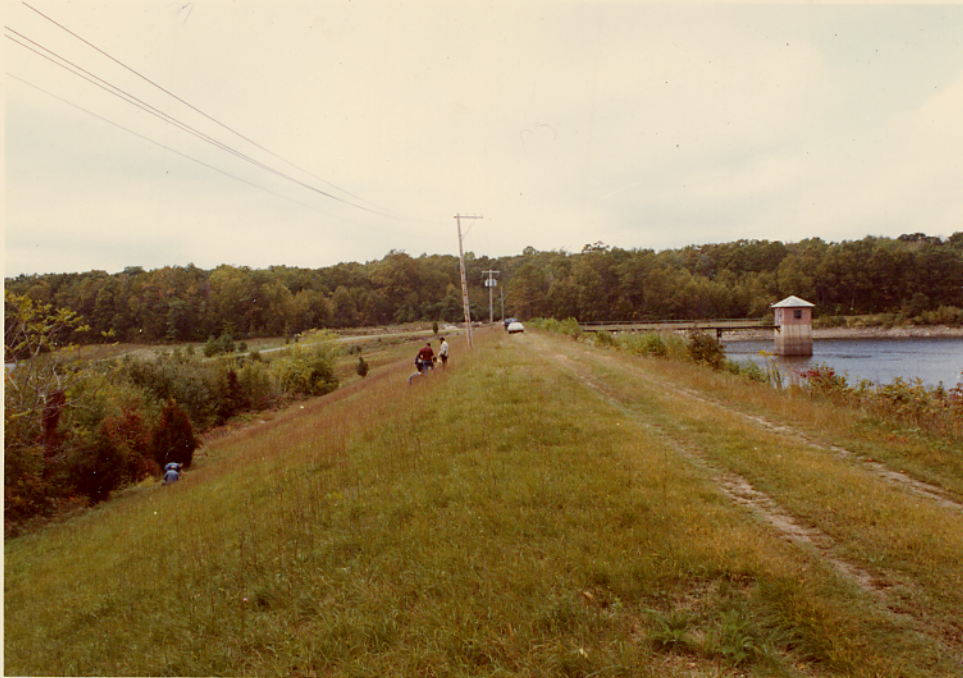
c. Appurtenant Structures - The gate house and wooden service bridge (Appendix C, Photo 2) are in excellent condition with no visible signs of cracking, spalling or distress. The valves and operators are operable and used as required to aerate the reservoir and control the supply of raw water to the filtration plant.

PHOTO 2
CREST OF DAM LOOKING WEST

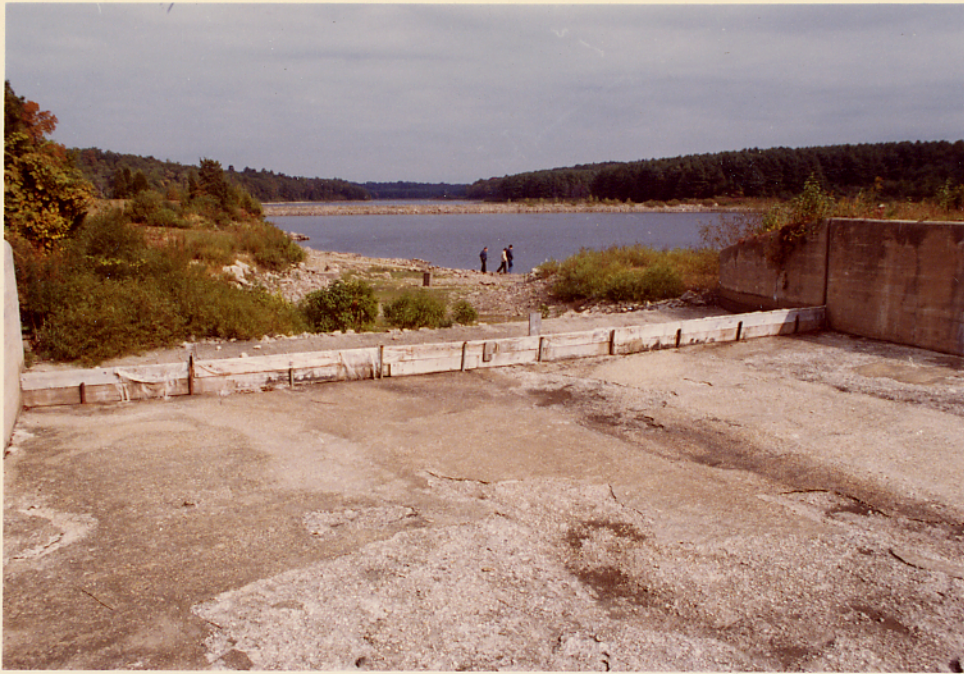
The spillway of the main dam dike (Appendix C, Photos 3, 4 and 5) is made of reinforced concrete that appears to be in very poor condition. The training walls of the approach area are distressed and cracked (Appendix C, Photo 6). The channel floor has exposed reinforcing and the concrete is spalling.

c. Visual Observations - The spillway at the time of the inspection was in poor condition with settlement of the channel floor, spalling concrete and exposed reinforcing bars.

PHOTO 3
SPILLWAY LOOKING UPSTREAM

- a. Alternatives - Not applicable.
- b. O & M Maintenance and Procedures -
 1. Brush and trees on the downstream slope and on the eastern wet area near the toe of the dam should be removed to facilitate the visual observation of existing and potential seepage, movements and pipings.
 2. Weakened and damaged concrete of the spillway should be removed and replaced. All concrete

surfaces of the spillway with caverns, potholes and cracks should be repaired.

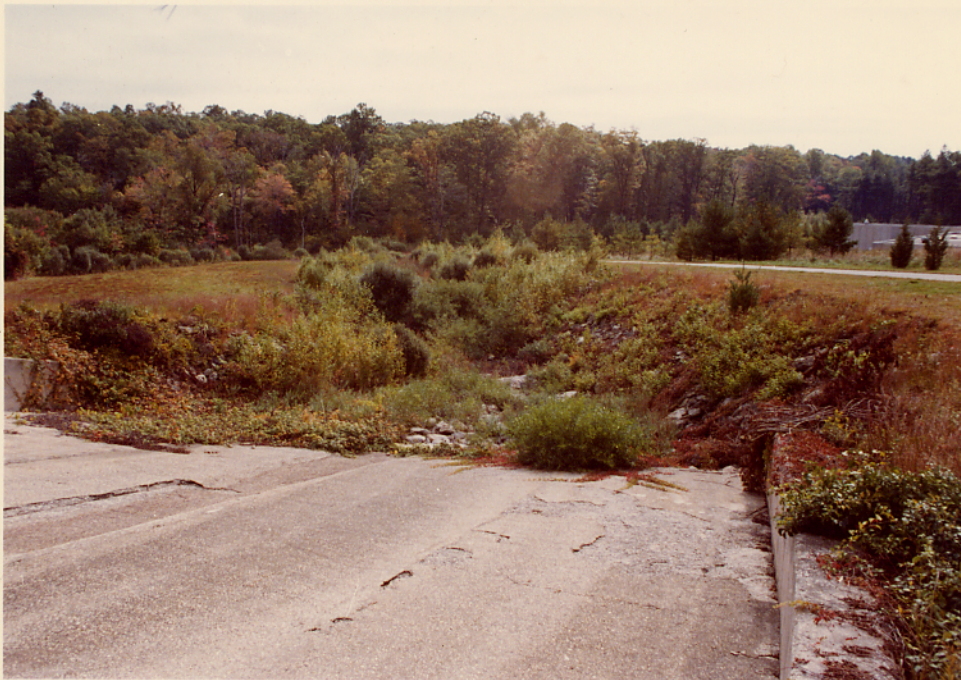
PHOTO 4
SPILLWAY LOOKING DOWNSTREAM

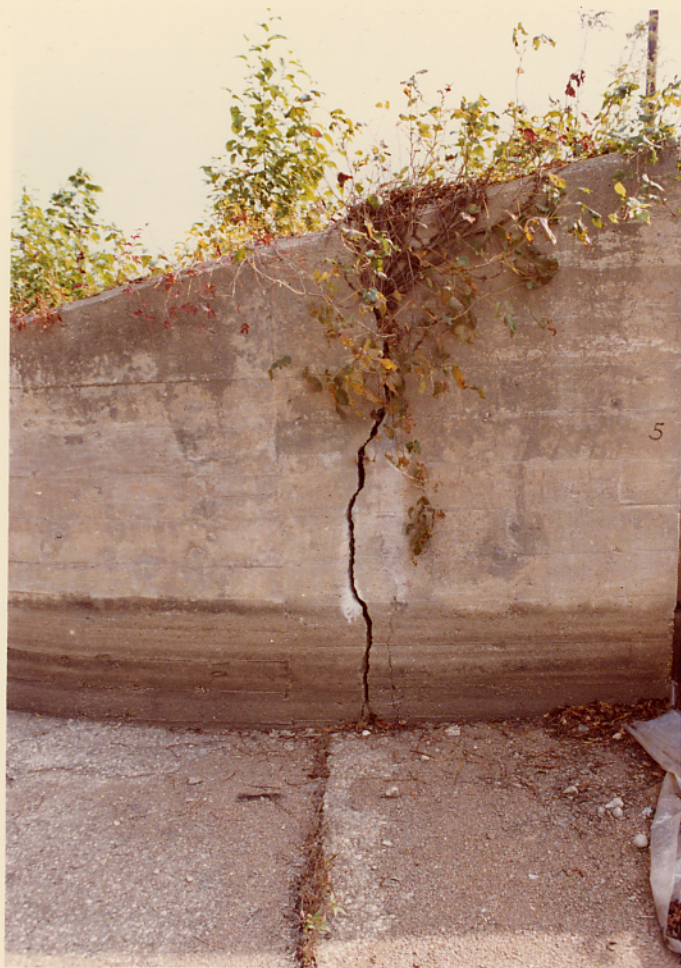
PHOTO 6
DAMAGE IN SPILLWAY RETAINING WALL

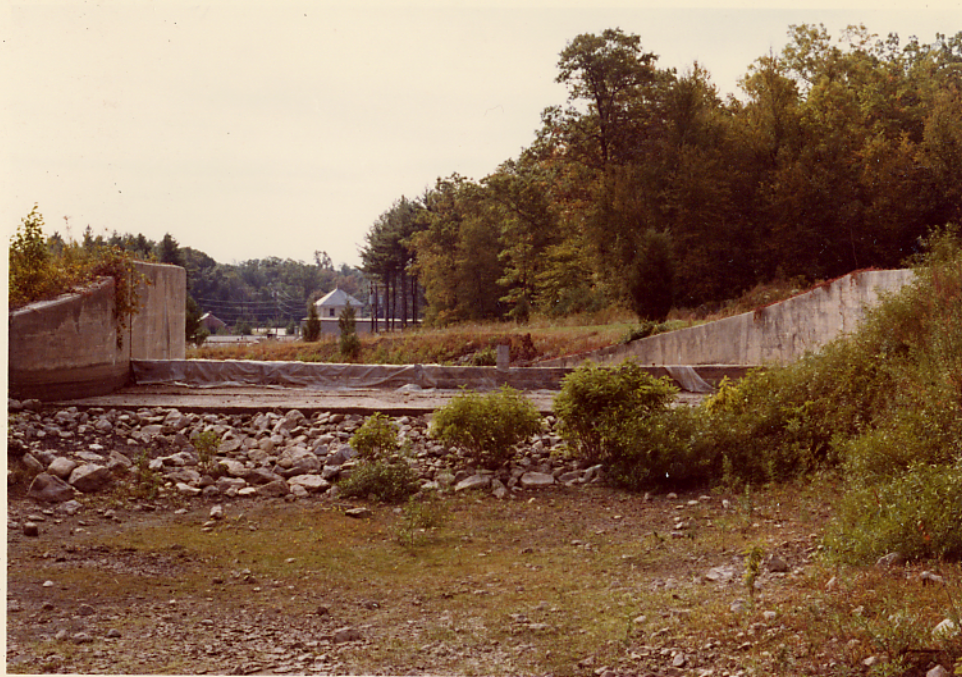
PHOTO 5
CREST OF SPILLWAY

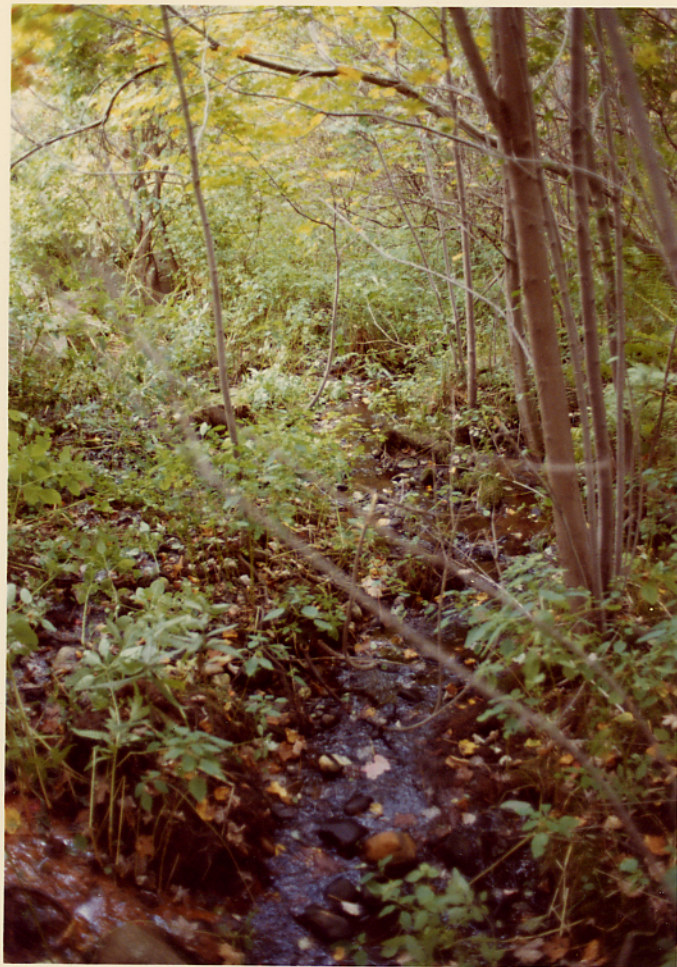
Seepage discharges in the vicinity of the toe of the main dam and the downstream earth slopes should be further investigated to determine their origin and monitored to determine any change. The spillway channel is in poor condition with many signs of cracking and spalling.

The seepage flows from the body of the main dam could not be monitored because there were no underdrains. The normal flow of the water through the dam appears slight and was observed at the rockfill toe of the main dam. Surface cracks, embankment bulges, piping or boils were not observed.

PHOTO 8
SEEPAGE AT TOE OF DAM

- a. Monitoring of the dam for seepage including any necessary seepage analyses or other pertinent studies.
- b. Determination of the elevations of the dam's base and condition of the rock foundation and concrete of the spillway.

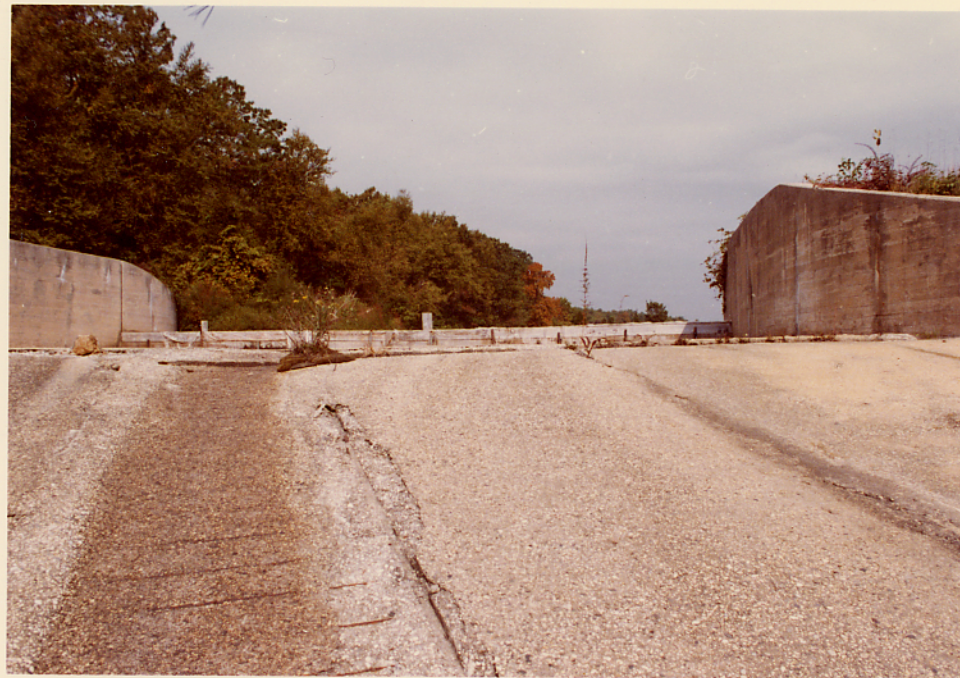
PHOTO 7
DAMAGE TO SPILLWAY APRON
